## Rio Tinto (Hope Downs) – Ecosoft Water Conditioner Trial

In February 2014 the Mobile Equipment Maintenance (MEM) department at Rio Tinto (Hope Downs) instigated a trial of an Ecosoft Water Conditioner on one of their Caterpillar MD6240 drill rigs.

The aim of the trial was to ascertain the effectiveness of the Ecosoft Water Conditioner in protecting the flushing water system and associated equipment from the build up lime-scale caused by the use of ground (hard) water in the system.

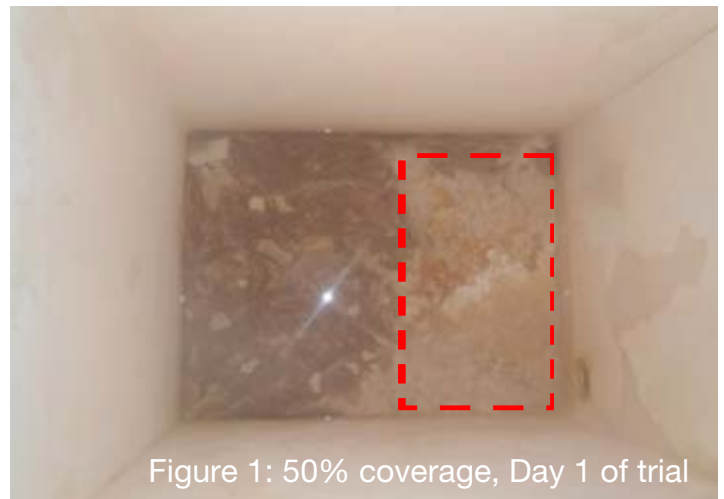
Figure 1: 50% coverage, Day 1 of trial

Figure 1 shows the build up of lime scale in one of the holding tanks that feed the flushing water system. It can be seen that the walls of the tanks are almost completely encrusted with scale. The floor of the tanks also show significant scale build up with approximately 50% coverage.

Prior to installing the Ecosoft Water Conditioner the existing scale was removed with the use of chemicals along with manual scrapping, chiselling etc.

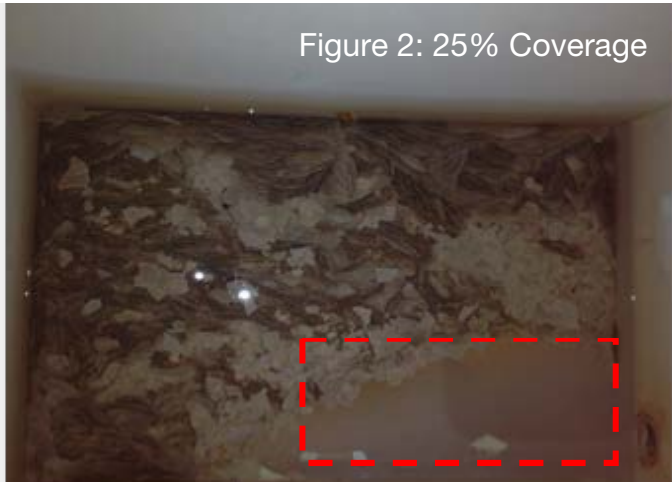
Figure 2: 25% Coverage

- Pre-existing scale in the tanks reduced by ~50% - Figure 2 & 3
- Remaining scale was becoming softer and easier to remove
- Suction line: “No visible build off scale inside the line” - Figure 4
- Y-Strainer: “Clean, no scale deposits”, residue “was very easy to scratch off” - Figure 5
- No new scale build up

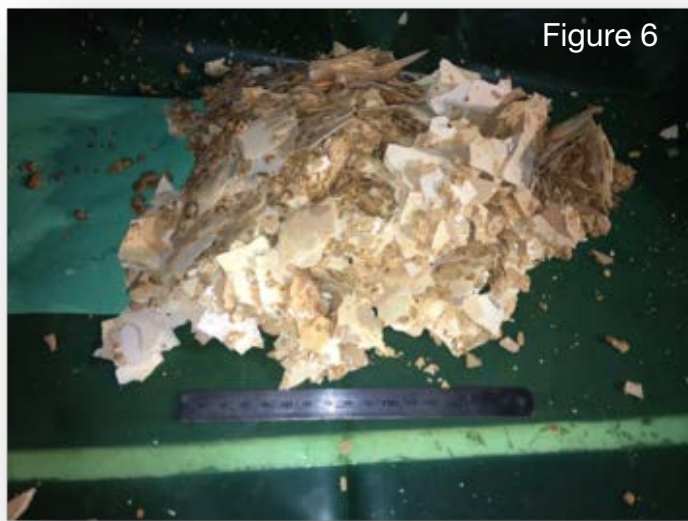
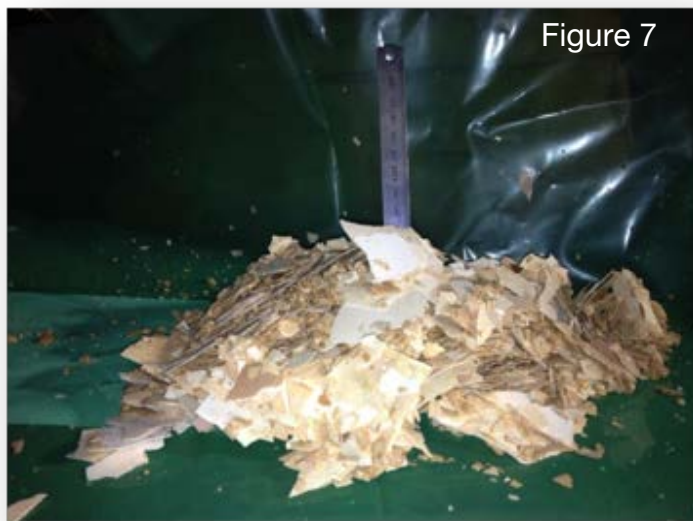
Figures 6 & 7 show the total amount of scale that was removed from the tanks. This scale was soft and pliable and easily removed by hand.

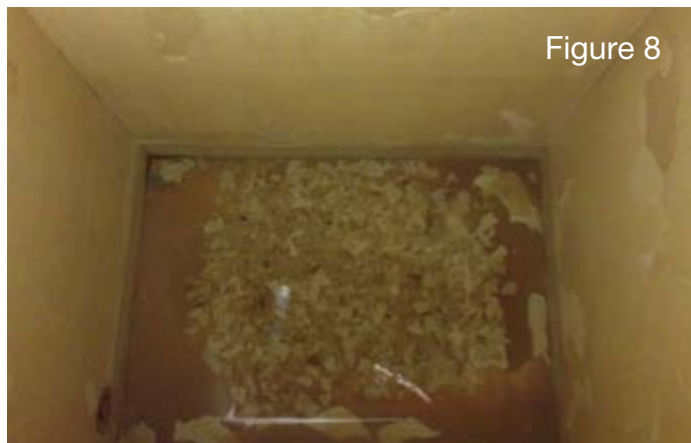
In Figure 8 the bottom of the tank is now clearly visible showing the degree to which the pre-existing scale has been dissolved by the Ecosoft Water Conditioner.

**No new scale build up was found.**
